Tactical Mission REPORT

MISSION NO. 263 287
FLOWN 12 Jul 1945
COPY NO. 58

**HEADQUARTERS
XXI BOMBER COMMAND
APO 234**

SUBJECT: Report of Attacks on 4 Cities and 1 Precision Target on Honshu on 12/13 July, 1945.

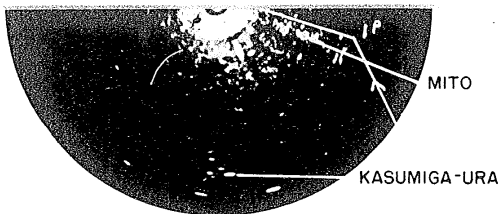
APPROACHES TO UTSUNOMIYA
ACTUAL SCOPE PHOTOS
ALT. APPROX. 10,000'

3. Utsunomiya was considered a difficult inland radar target, but the radar return showed up well above 12,000 feet and for that reason the bombing altitude of 13,000 to 13,800 feet was specified. The only good radar approach was upwind and it was directed that direct radar synchronous bombing be used.

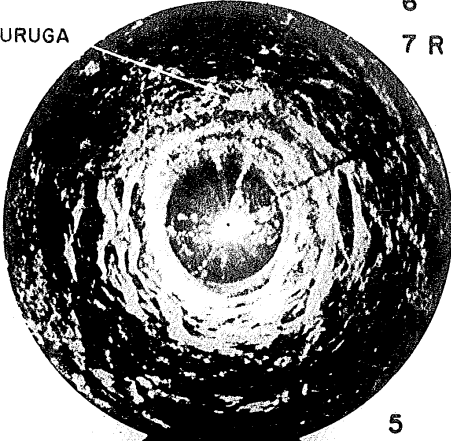
APPROACHES TO TSURUGA
ACTUAL SCOPE PHOTOS
ALT. APPROX. 10,000'

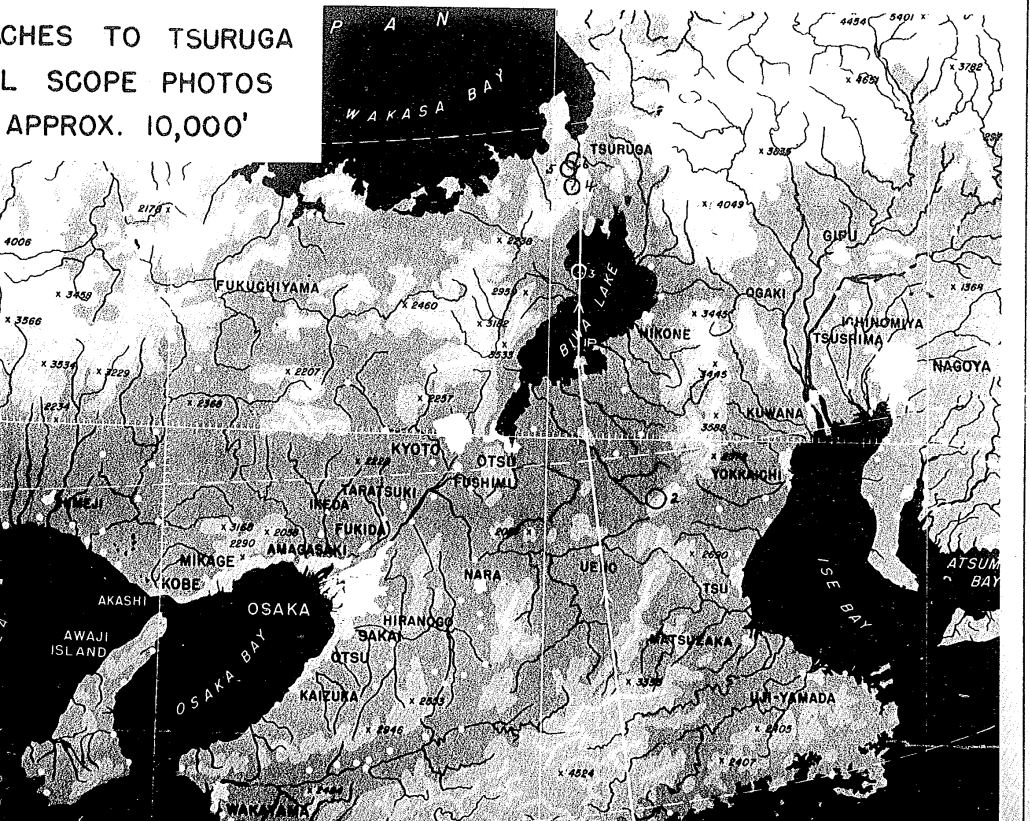
SHEET RM - 67

CHES TO TSURUGA
L SCOPE PHOTOS
APPROX. 10,000'
